Jun. 21st Solar PV Modules Testing, reliability, lifetime Alejandro Borja Block - EPFL

GLOBAL OPTIMIZATION OF INTEGRATED PHOTOVOLTAIC SYSTEM FOR LOW ELECTRICITY COST

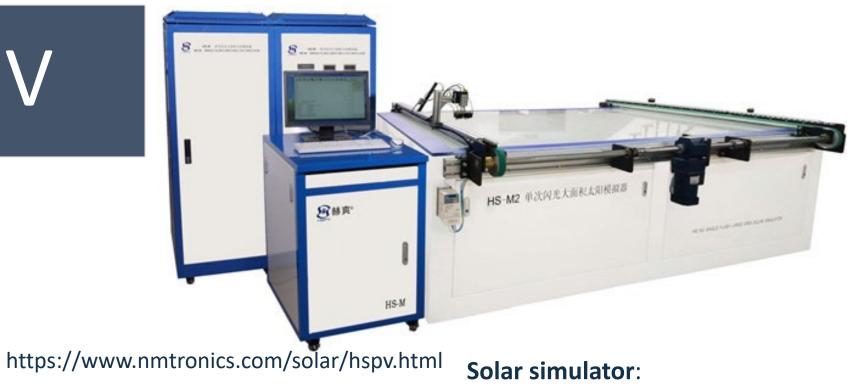
- Connect J-box
- $1000 \text{ W}/m^2$
- A few seconds
- Classify modules according to power generation

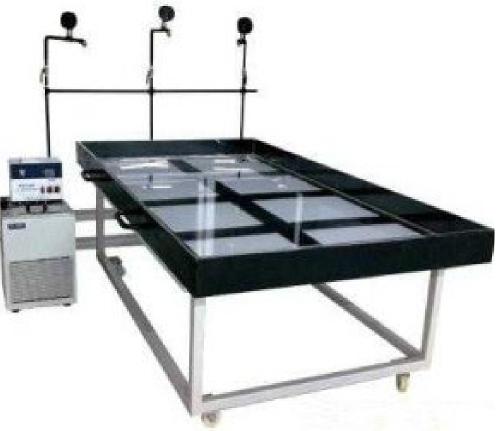
HIPOT /WET LEAKAGE TEST  $\rightarrow$  insulation of internal electrical circuit

### **HIPOT**

• Done for every module (dry)

### WET LEAKAGE TEST

- Some modules
- Module covered with water
- Max. system voltage x2 applied to cells
- Isolation resistance times module area ≥ 40 MΩ/m2

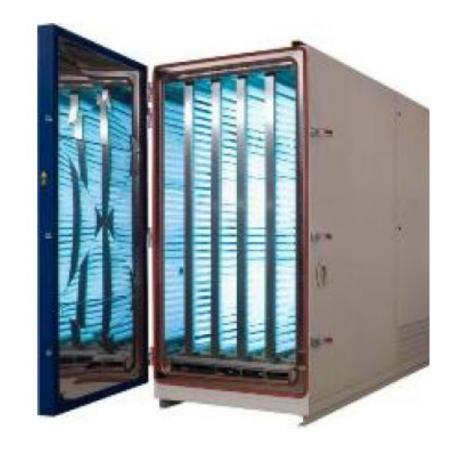
## **Climatic: UV**

#### **Test conditions**

- 15 kWh/m2 (61215)
- 2x60 kWh/m2 (61730)

- Delamination of encapsulant
- Encapsulant loss of adhesion and elasticity
- Encapsulant discoloration
- Ground fault due to backsheet degradation

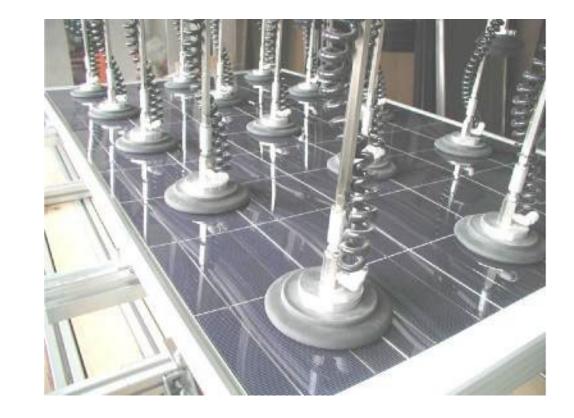
## **Mechanical: Load**

#### **Test conditions**

- 3 cycles
- +/- 2.4 MPa

- Glass and cell brakeage
- Loss of electrical continuity
- Solder joint failures
- Frame deformation

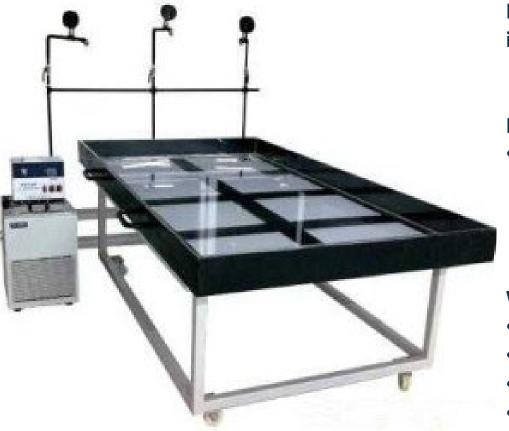
HIPOT /WET LEAKAGE TEST  $\rightarrow$  insulation of internal electrical circuit

#### **HIPOT**

• Done for every module (dry)

#### WET LEAKAGE TEST

- Some modules
- Module covered with water
- Max. system voltage x2 applied to cells
- Isolation resistance times module area  $\geq$  40 M $\Omega$ /m2
